## JUSTIFICATION FOR ARTICLE 4 (1) DIRECTION - EXAMPLES from 2005 and 2014

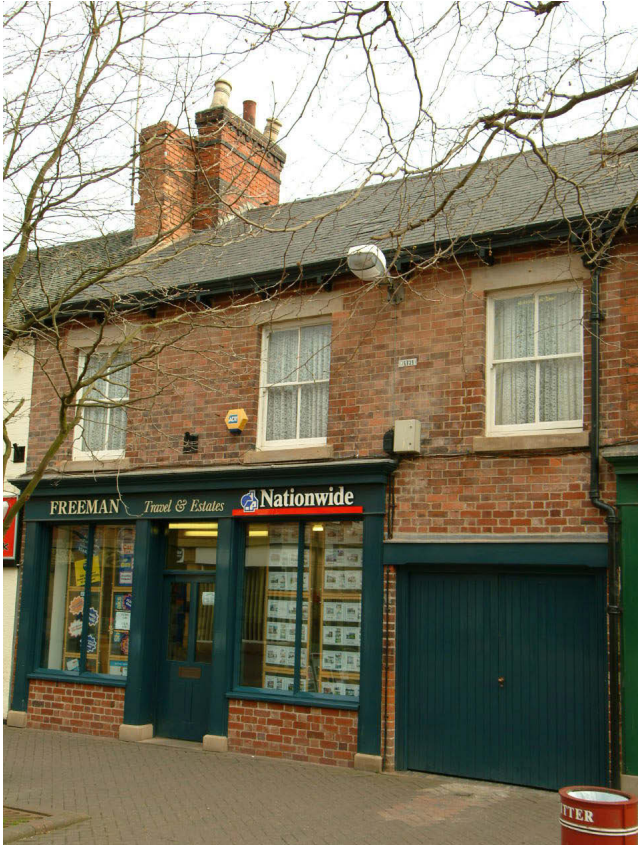
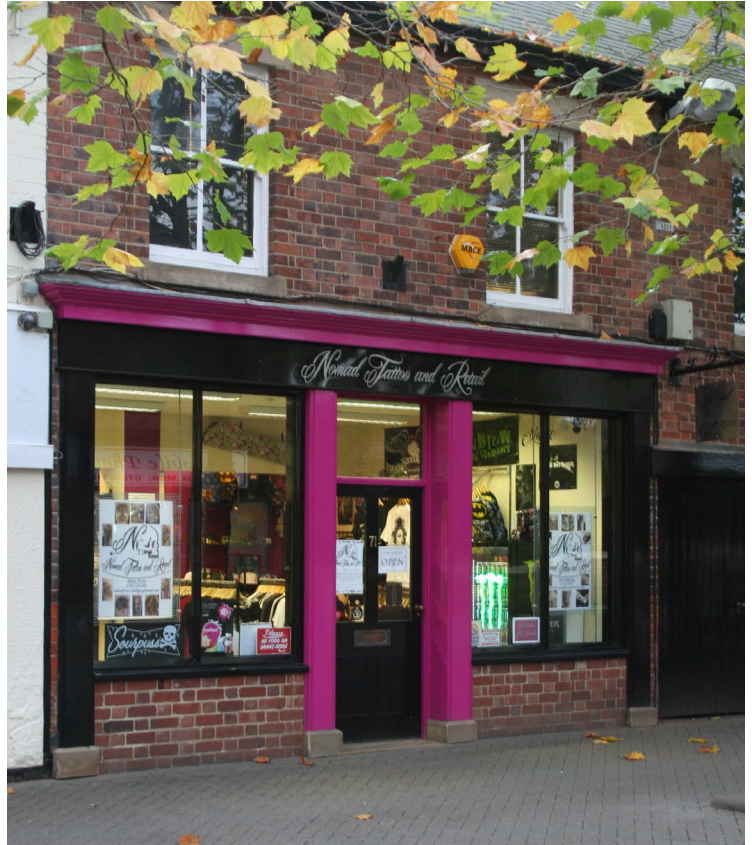
Changes to paint colours can dramatically affect the appearance of a traditional shopfront. The shop unit and elevations at 71 High Street (above), photographed in 2005 and 2014, were restored with grant-aid from the local partnership scheme. The change from an estate agency to a tattoo parlour required a change of image - the black with pink highlights is a bold contemporary twist. Although not included in the palette of approved colours, the requirement for planning permission for this colour scheme would have involved an assessment of whether this would be a positive step in the conservation area.

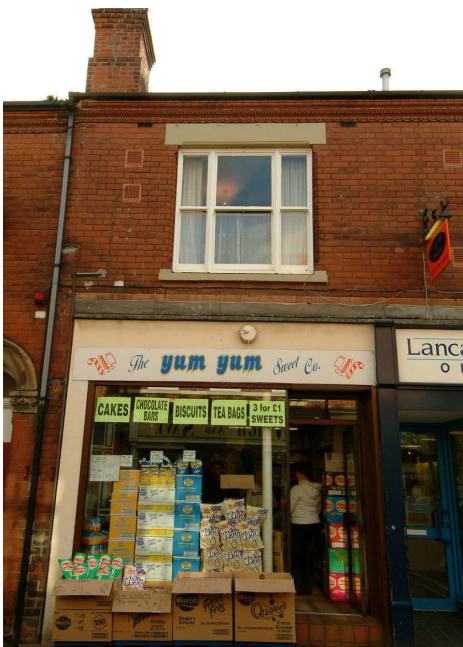
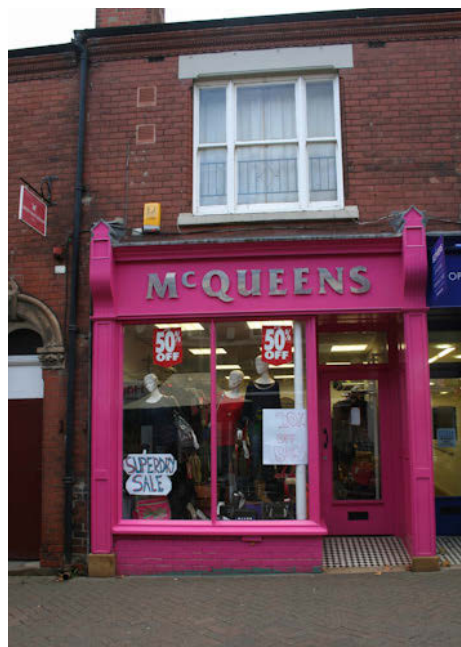
The shop at 20 High Street (below) was also restored with grant assistance. Left - the shop in 2005 and right - the shop in 2014. Planning permission is currently not required for a change to the colour scheme. If the Article 4 had been in place, the present hot pink colour scheme is unlikely to have been approved.

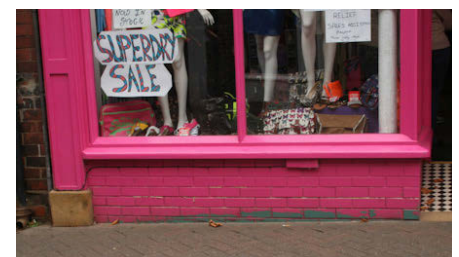
More damaging than the colour scheme, which is reversible, is the painting of the glazed brick stall-riser, which was installed with grant aid. Removal of paint from glazed bricks and joints could damage the face of the bricks. Currently planning permission is not required for painting masonry.

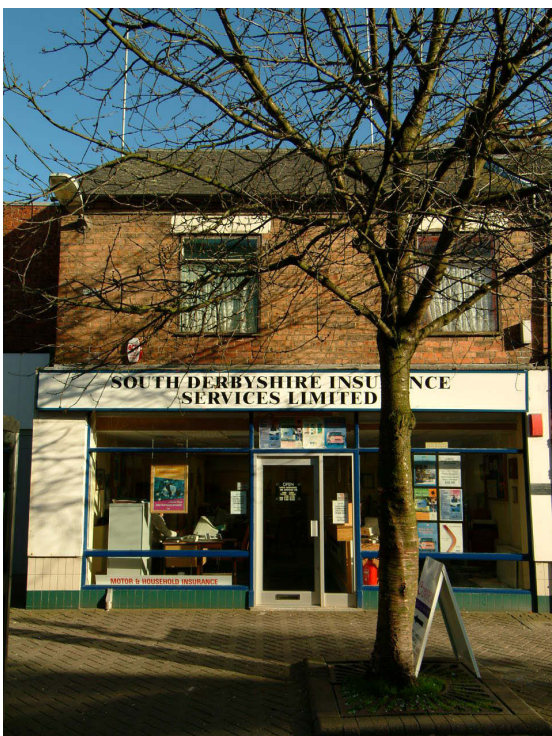
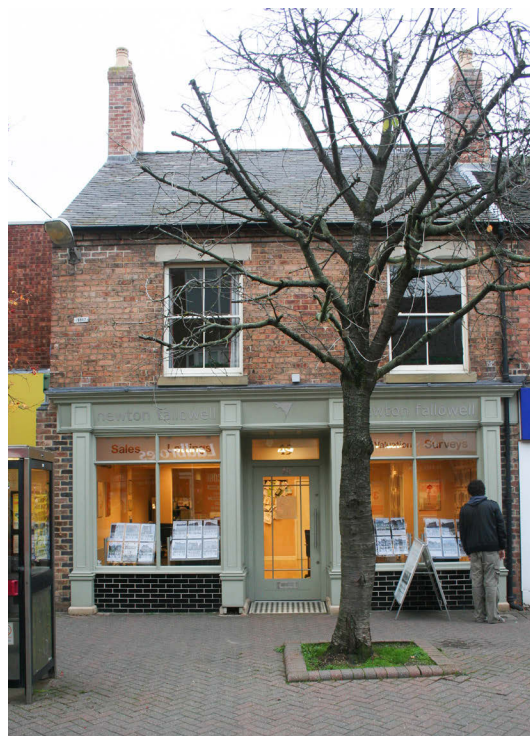
The comprehensive restoration of No. 49 High Street (left) involved rebuilding the chimney stack, reinstating sash windows and installing a new shopfront with glazed brick stall-riser. Photographs from 2005 and 2014. Re-painting and changes to the advertisements could easily affect the character of this restored building.

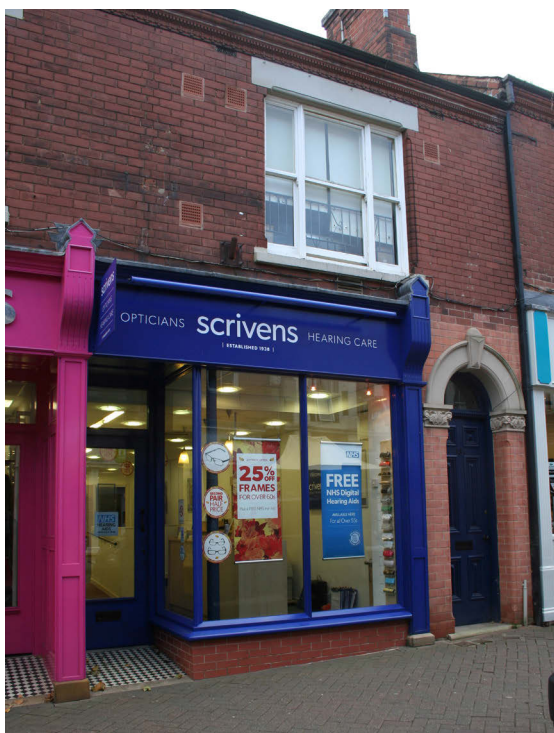
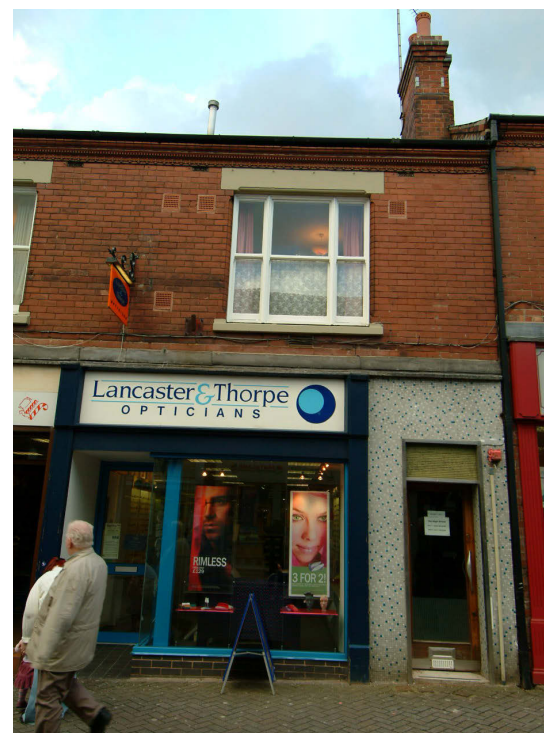
Restoration of the Edwardian shopfront at 18 High Street (right - 2014 and far right - 2005) also involved extensive works to remodel the entrance doorway to the flats and restore the arched stone decorative doorcase. As planning permission is not needed for painting, this could easily be disfigured by painting.

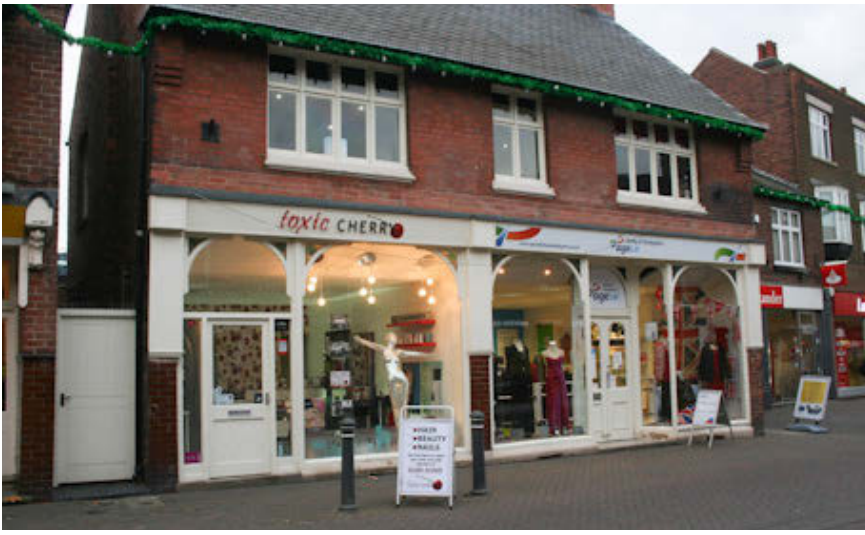
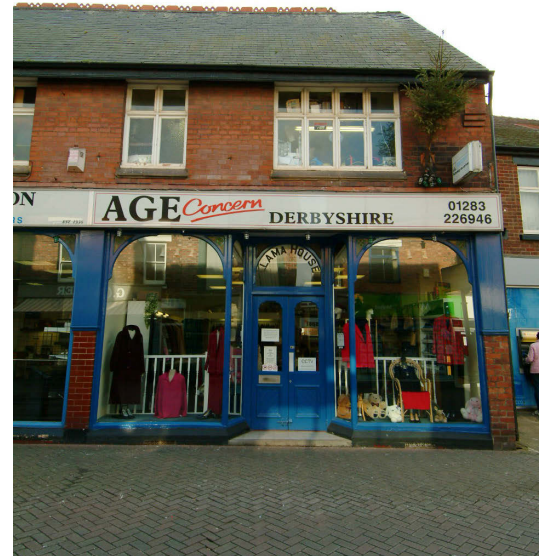
The repair and restoration of the Edwardian shopfront at Nos. 56-58 High Street involved the cohesive painting of the shops to restore the simple character. In removing the large “detached” fascia panel, this has enhanced the character of the shopfront. Above - 2014 and right - 2005. Painting could easily alter this restored appearance by creating a disjointed shopfront.

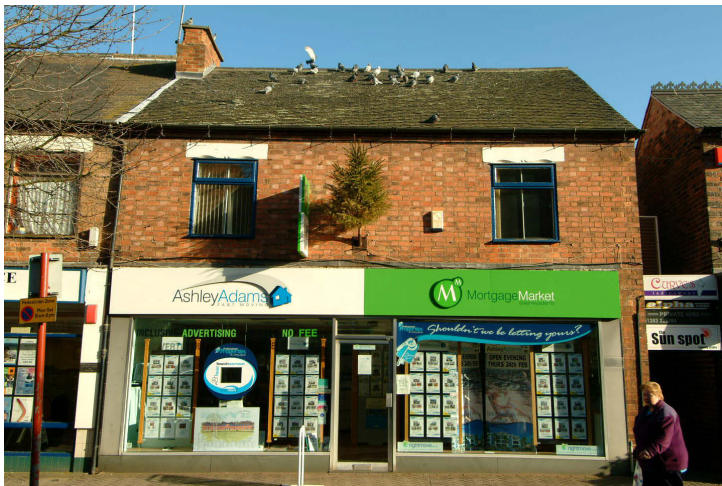
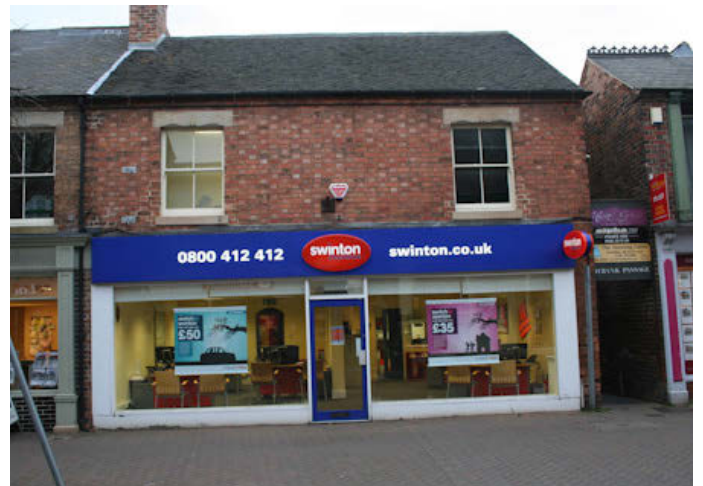
Left - 2005. Enhancement work to 51-53 High Street, grant-aided under the Partnership scheme, involved reinstating sash windows to the first floor (right - 2014). Repainting these windows a dark colour or painting the restored brickwork could make a significant difference to the character of the area.

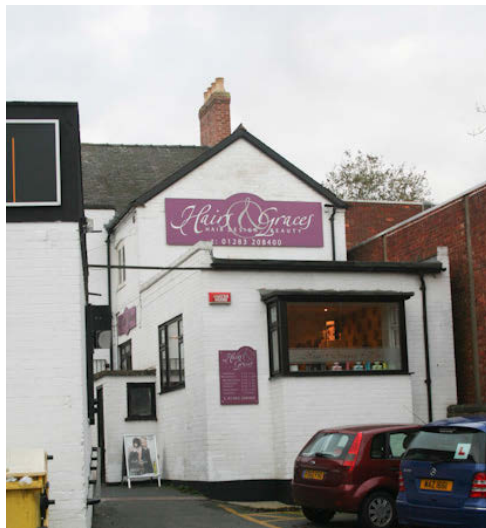
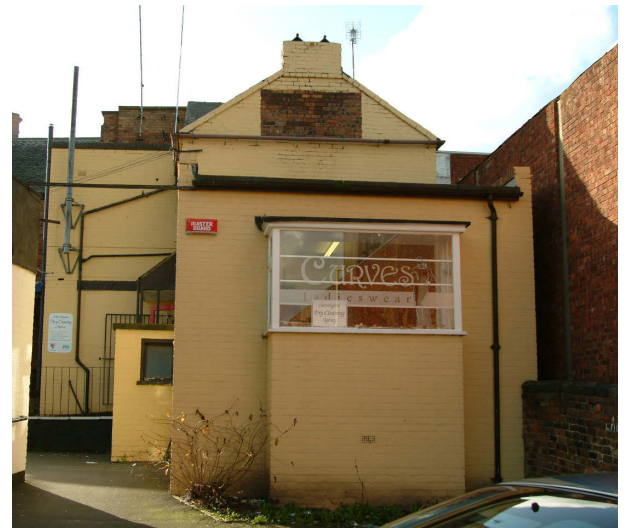
Right and far right - 2014 and 2005. The painting of brickwork does not need planning permission but can make a significant difference to the appearance of the conservation area.

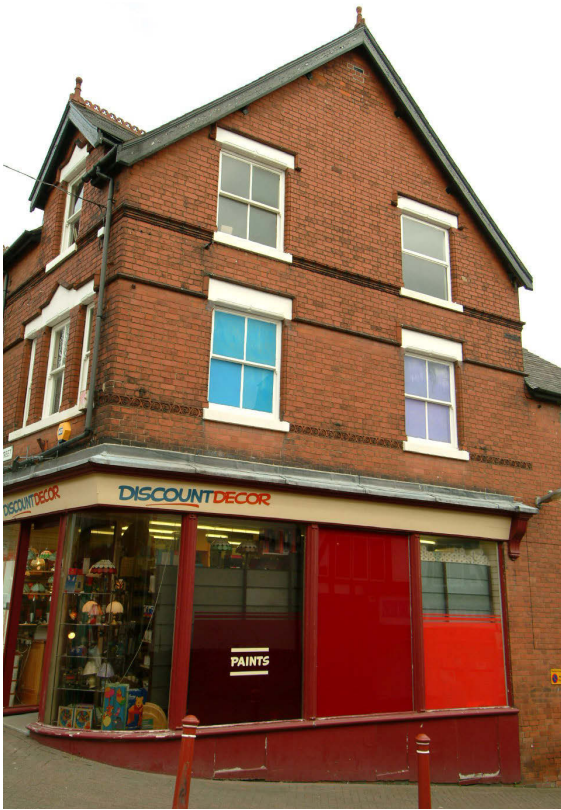
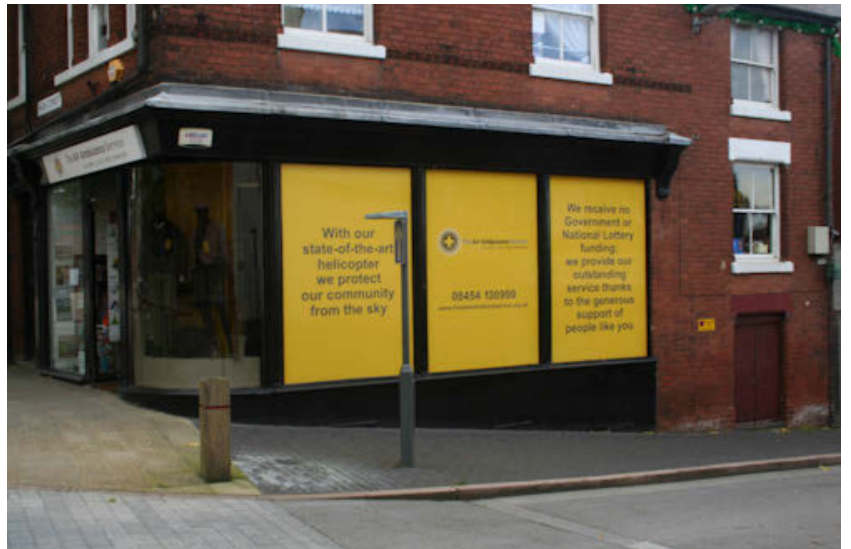
Before and after - No.5 High Street in 2005 (left) and in 2014 (right)

Although the paint scheme has unified the shopfront, the rather dramatic yellow advertisements inside the glass are permitted development.

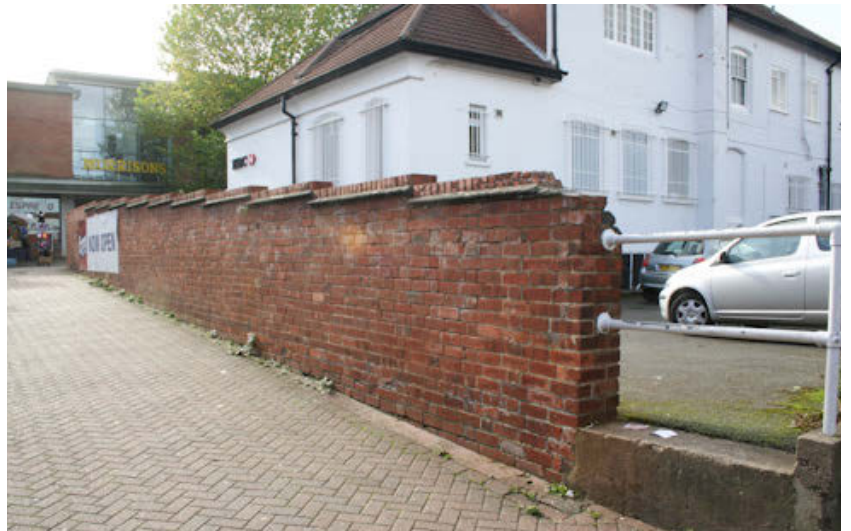
Boundary walls behind retail units are particularly vulnerable to alteration. The walls behind shops on the south side of High Street (below) were reinstated and restored with grant-aid. This important work could easily be undone by small-scale demolition. An Article 4 Direction would require planning permission to be submitted for alteration and demolition.

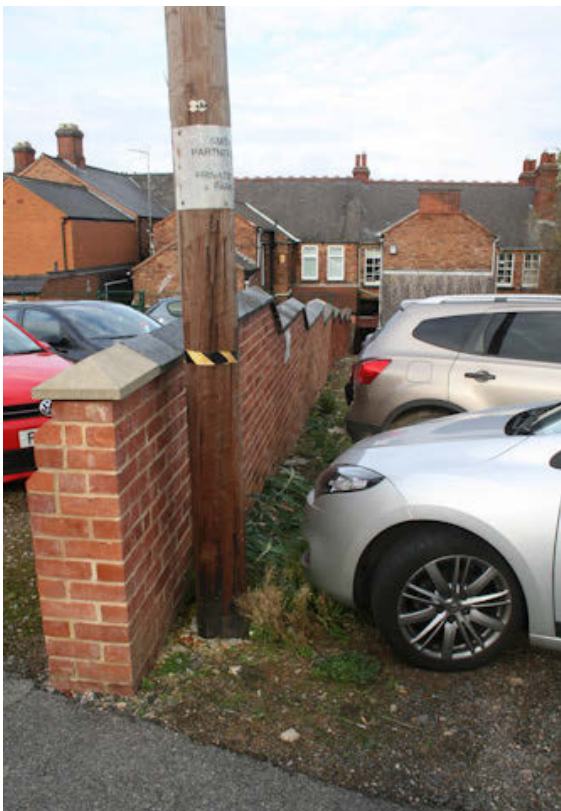
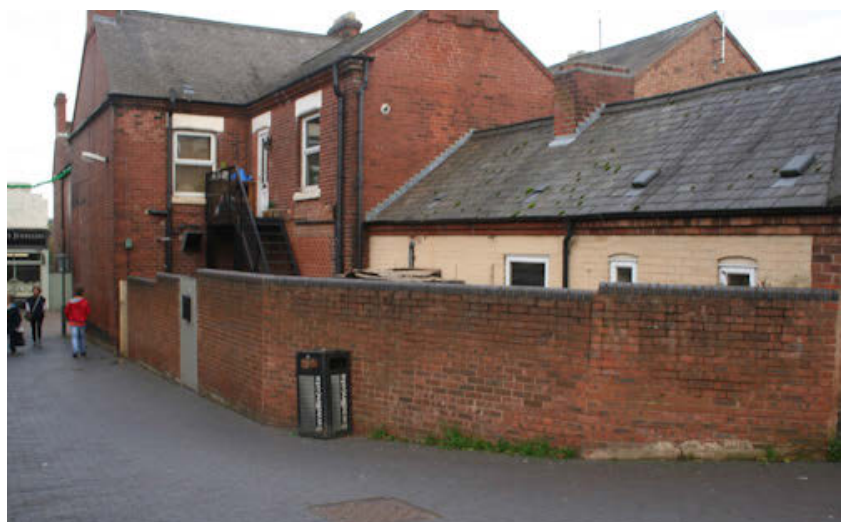
Passages leading from the High Street, between the buildings, are often lined with simple brick walls disguising yards. Demolition of these walls would lead to significant loss of enclosure and local character.

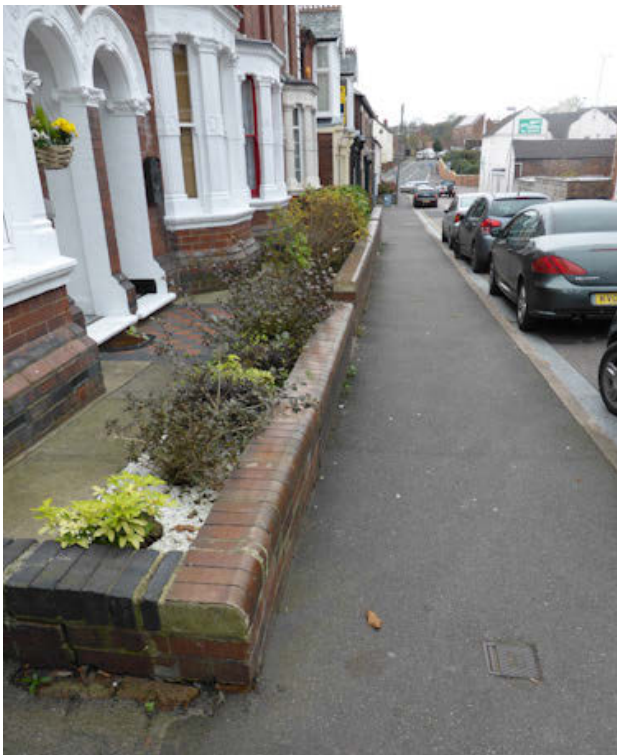
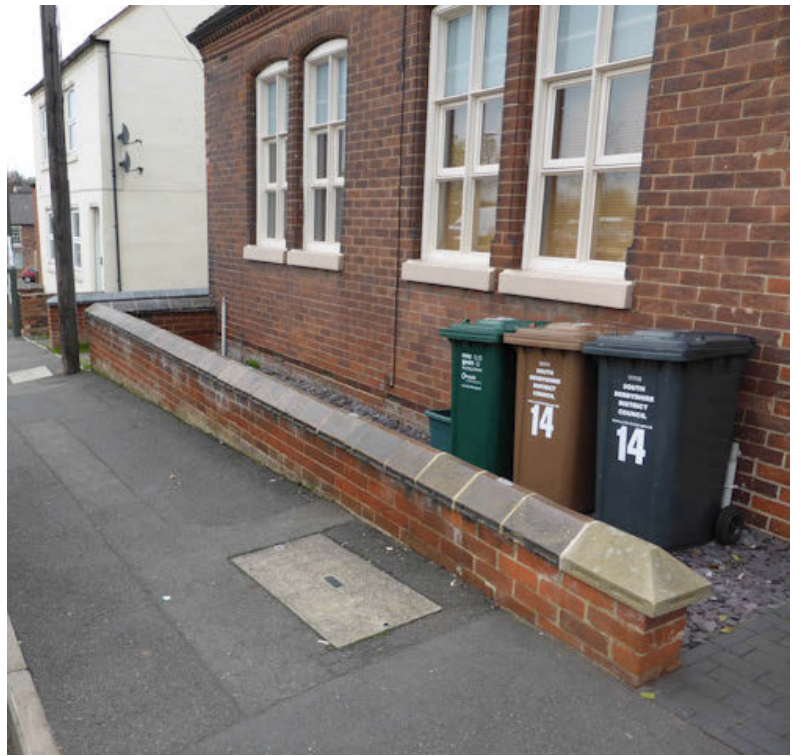
Above left - salt-glazed, bull-nosed copings to dwellings at Church Street are a rare survival and salt-glazed saddleback copings have been restored (above right) at 12-16 Coppice Side under the recent partnership scheme. At present, sections of these walls could be removed without planning permission.

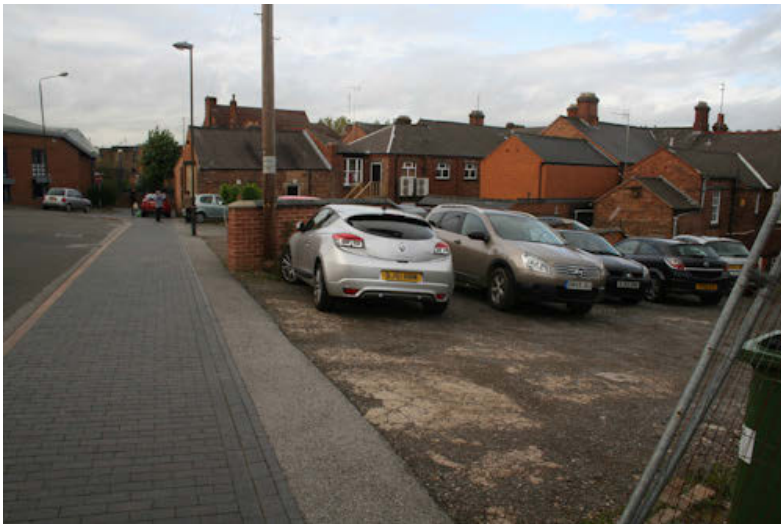
Left - Ernest Hall Way. The back walls of properties fronting High Street have largely lost their boundaries. Future plans to potentially restore boundary walls to this frontage, to provide enclosure to the frontages, need a degree of protection so that they cannot be demolished without applying for planning permission.

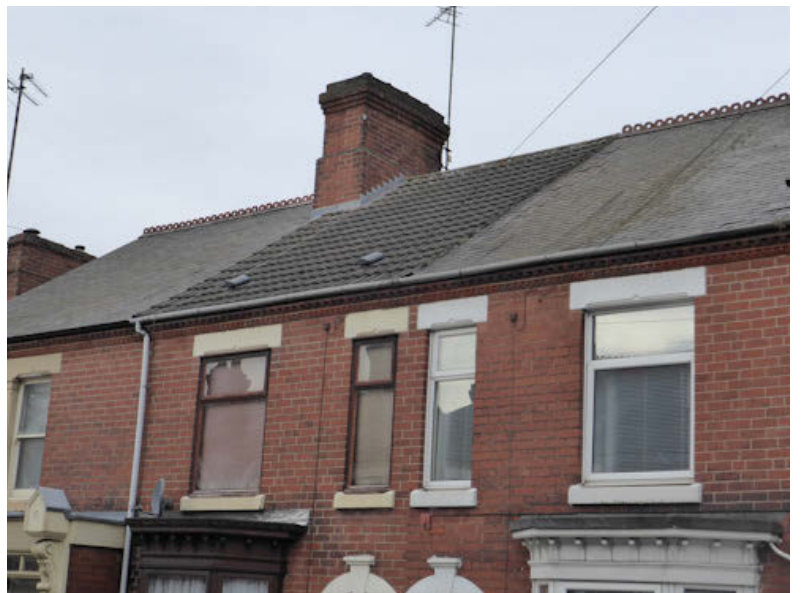
Right - the replacement of Welsh slate roofs with concrete tiles is a major loss to historic character. This example on Church Street stands out in a uniform roofscape. Alterations like this, to domestic properties, are currently permitted development.
